PATIENT LEAFLET

ECOFIT[®] 2M HIP SYSTEM

VALID FOR: AUSTRALIA

DATE: 03.02.2022

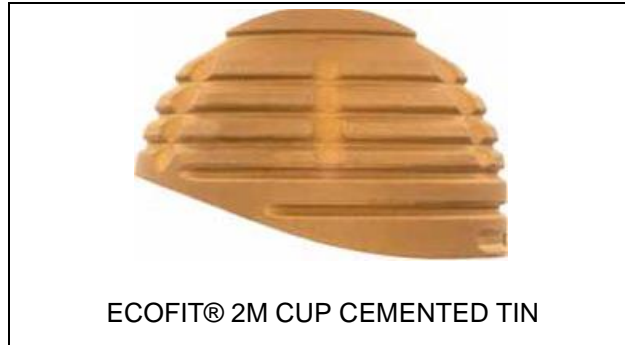
EcoFit® 2M cup cemented TiN:

EcoFit® 2M cup cemented TiN is coated with TiN, which is applied on the whole cup. The EcoFit® 2M cup cemented TiN is intended for a cemented fixation.

EcoFit® 2M cup cemented TiN is an acetabular component with an inner articulation surface. It is part of the modular dual mobility hip replacement system, which is intended for the total hip arthroplasty. It is intended for a cemented fixation.

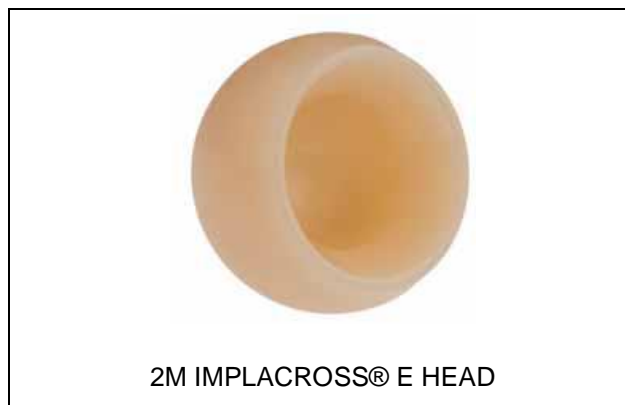
2M implacross® E head:

2M Implacross® E head is made of cross-linked UHMWPE with vitamin E. The 2M implacross® E head rotates freely in the EcoFit® 2M cup.

2M implacross® E head is a dual mobility acetabular cup insert, which has outer and inner articulation surfaces. It is part of the modular dual mobility hip replacement system, which is intended for the total hip arthroplasty.
